# How do you remove and prevent flash rust on stainless steel?

One of the problems of stainless steels is that they are susceptible to rust if they do not have correct maintenance. In this article, some common rust problems are dealt with, and it is shown how the rust can be removed by using a simple kit consisting of two liquid agents and a special sponge.

*N. W. Buijs – Metallurgist – Innomet b.v.*

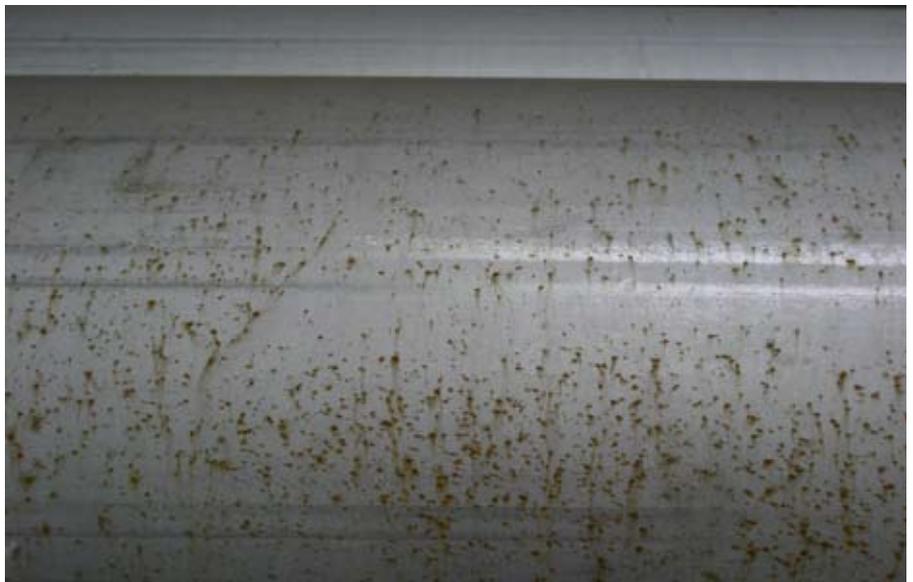
Fig. 1. contamination corrosion on stainless steel tubes caused by carbon steel grinding.

One of the causes of flash rust, also known as rust film, is when small steel particles fall or swirl down onto a stainless steel surface. When combined with moisture, they quickly dissolve due to the base character of the steel particles (see Fig. 1). There is a relatively large potential difference between stainless steel and carbon steel, which is why this reaction occurs extremely quickly. In practice, the term 'iron particles' is often used, but what is actually meant is 'steel particles'. During dissolution of the steel particles, iron oxides are created that contaminate the surface of the stainless steel. In addition, oxygen is somewhat prevented from entering the area, as a result of which the stain-

less steel surface becomes activated locally. This then leads to contamination corrosion. Examples include steel particles that are the result of wear and tear, such as near to railway tracks, as well as grinding dust and showers of sparks that develop during carbon steel grinding. The latter particles are particularly dangerous because they can burn into the stainless steel surface whilst the core of these particles still contain unburnt steel. In addition, the abrasive movements of carbon steel and stainless steel together can also lead to contamination corrosion in the end. This is why stainless steel needs to be protected from carbon steel and must be processed separately from carbon steel. If the latter is not possible than pickling and passivating stainless steel offers a good option to become free of any undesired steel particles.

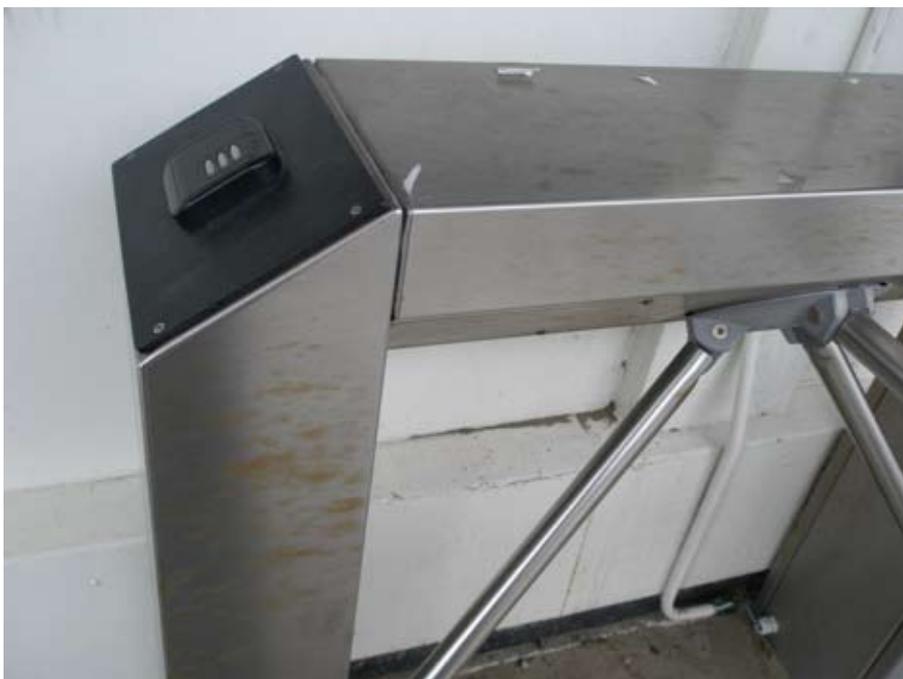
Fig. 2. RVS 316 access gate corroded by aerosols.

Local rust spots can also develop due to aerosols, for example, and this primarily occurs in coastal areas. Aerosols are small droplets of seawater that are carried from the sea by the wind and which evaporate during their flight leading to a further increase in salt and chloride concentrations. This forms a greater corrosive load for stainless steel than normal seawater. The result is local corrosion that can also even lead to pitting corrosion at times. The effect of this action can regularly be seen on stainless steel parts on or near the shore in particular. In Fig. 2 you can

see an access gate made from stainless steel 316 that is situated near to the coast. Rust spots, which in this case are also known as tea stains, can clearly be seen.

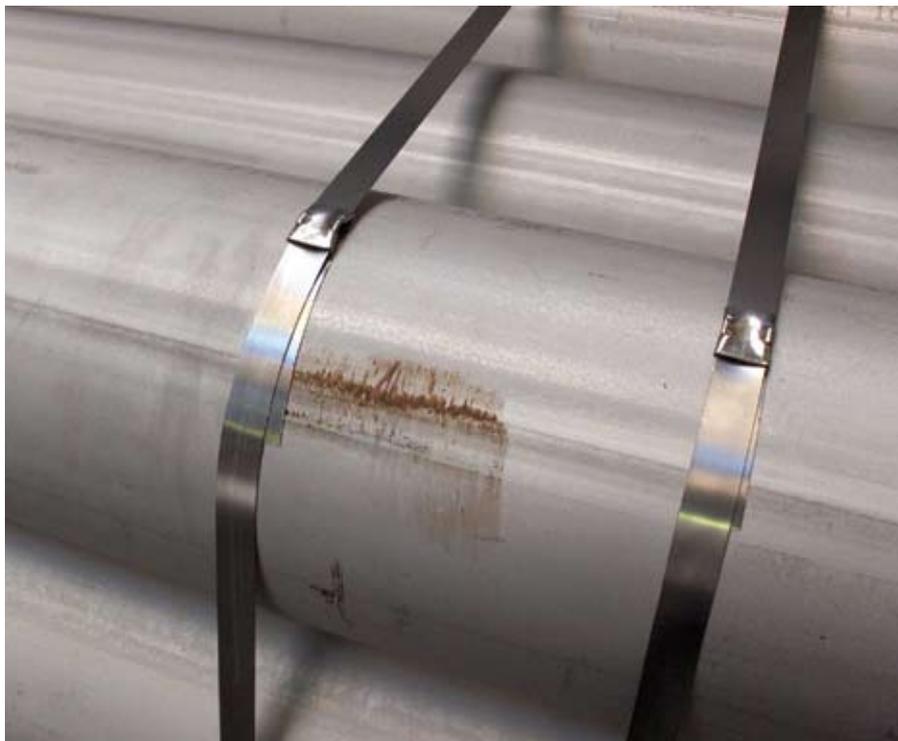
Fig. 3. Contamination by a steel object such as the fork of a forklift truck.

Another common reason for contamination corrosion is the contact between carbon steel and stainless steel due, for example, to steel forks of forklift trucks, nails on pallets, contact with Stelcon plates, steel tools, steel transport rollers etc. An example of this can be seen in Fig. 3. Corrosion prod-

ucts can clearly be seen seeping out of the 'wound', causing further contamination to the surface. If this damage is not removed then the corrosion will quickly continue in this area until the material is bored through locally as it were. The speed with which it happens is due to the fact that contact occurs between a small anode and a large cathode.

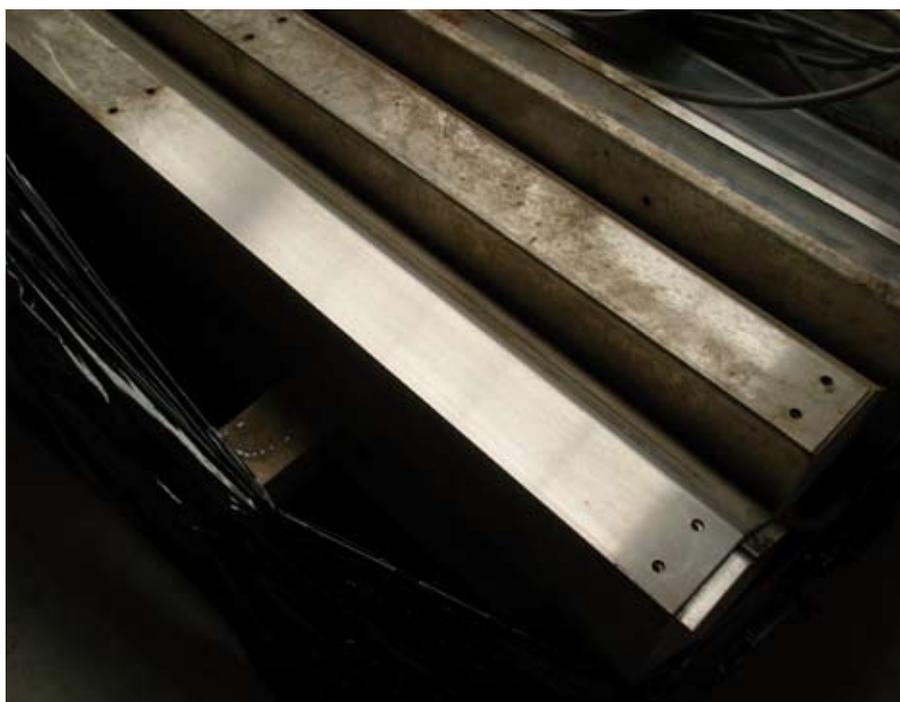
Fig. 4. Contamination corrosion on 316L light fittings (the bottom fitting has partially been treated with the organic acid Innosoft B570).

Local rust formation can be removed with pickling liquids or pickling pastes as well as with inorganic chemicals. In some cases this can also be done mechanically with, for example, sandpaper, special scourers or stainless steel brushes. The disadvantages are generally well-known, as scouring damages the surface considerably and, in addition, the scoured area is often less corrosion-resistant. Pickling is harmful to the environment and dangerous for the people working with it. Regular inhalation of the hydrogen fluoride present can even lead to a pulmonary embolism. The use of inorganic acids also has its dangers and is also subject to stringent rules and guidelines. This is why an oxide-dissolving organic agent called Innosoft B570 is now available that gives a very effective and efficient result. In Fig. 4 you can see light fittings made from stainless steel 316 that were only in use in a maritime environment for one and a half years. The top sections still show the severity of this contamination by aerosols. After use of the organic acid Innosoft B570, the surface was quickly restored to its original condition. The bottom fitting has partially been treated with this. And yet one must not lose sight of the fact that small scars may have developed in the surface that could quickly lead to new corrosion as soon as the fit-

tings are put back in place. This is why a basic neutraliser has been developed that also deposits a nanolayer on the surface to provide protection against possible new corrosion. This product will be introduced on the market under the name Innoclean B560. A maintenance protocol will also be needed in this case as all things come to an end. In other words, the surface will need to be cleaned and the nanolayer reapplied periodically.

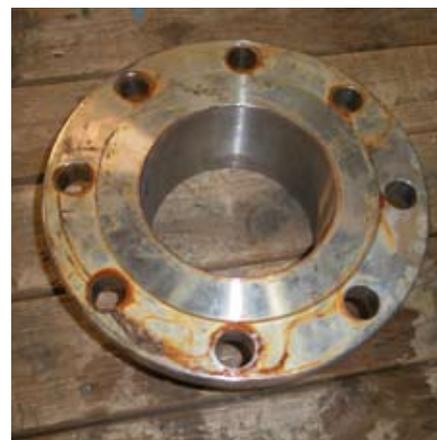
Fig. 5. RVS 304 flange contaminated by ferruginous water.

Various maintenance advice can be found on the Internet regarding stainless steel. Unfortunately, reputable companies sometimes issue advice that is often at odds with what should actually be done. For example, advice is given to clean contaminated stainless steel with steel wool or a scouring sponge. This should particularly be avoided as steel wool is something that contaminates stainless steel and a scouring sponge damages the surface. This is why Innosoft B570 is a product that only dissolves the iron oxides and also has a deep cleansing effect. In other words, it is gentle on stainless steel but tough on oxides and all kinds of dirt. A good example can be seen in Figs. 5 and 6. A stainless steel flange 304 was kept in a plastic bag in which ferruginous water was present. The flange came out the packaging in such a state that it was ready for the scrapheap. This problem was easy to solve with the afore-mentioned organic cleaner and the flange was recondi-

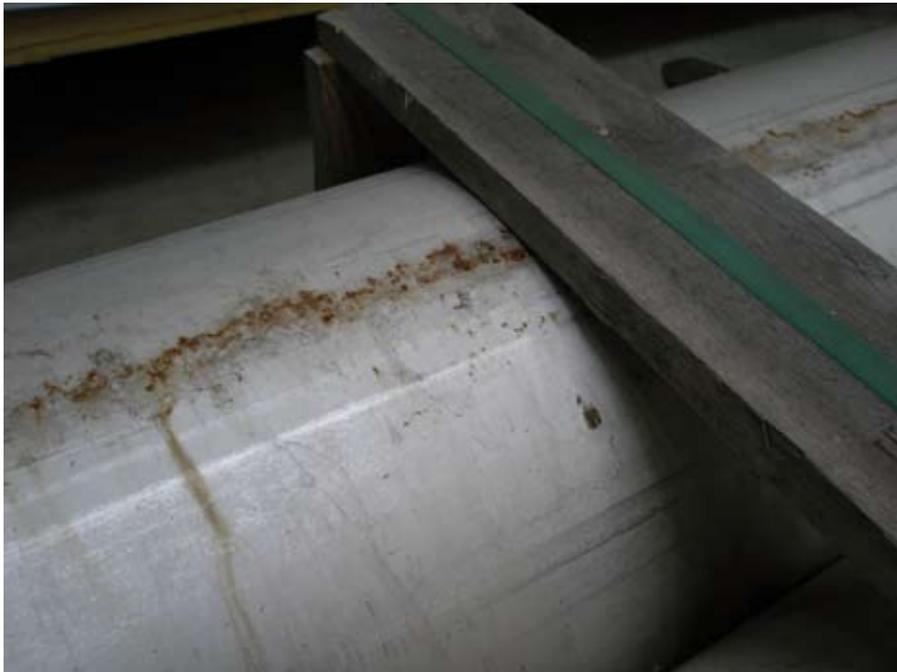
Fig. 7. Stainless steel 316 tube that was badly contaminated by steel grit on a building site.

Another example is a seriously contaminated stainless steel tube that was lying at a building site (see Figs. 7 and 8). A section on the left of the bar was the only part treated with this particular organic acid and the result exceeded all expectations.

It would be sensible to mention that corrosion pits will of course remain, but the pits are, however, stripped of the harmful corrosion products. These imperfections do require extra care as they can quickly set the corrosion mechanism in motion again. In that case, the invisible nanolayer also provides some additional protection.
